Product Awareness Notice 06001 Version 1.0 Date 1/02/2006 Page 1 of 2

Products affected Datatenna Transmitter
Datatenna Repeater
RDC Transmitter
RDC Repeater

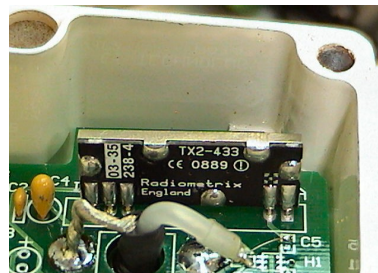
Prior to December 2004, EIT used a 10mW Radiometrix transmitter chip in Datatennas and RDC units. These radios were capable of transmitting about 1km in good line-of-sight conditions.

Low power Radiometrix module

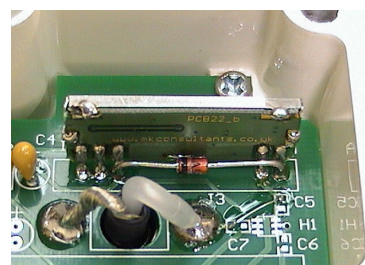
Subsequent to that time, the chip was upgraded to a 25mw Genesis GT1. The latter has vastly increased range, up to 4km in good line-of-sight conditions.

High power Genesis module
