Product Awareness Notice 06005 Version 1.0 Date 23/5/2006 Page 1 of 2

Products affected **IPC Series 1 (PIC based)**
 Serial numbers All
 Action required None – Advisory only
 Reason for notice Provides information on **firmware and compatibility** issues with IPC devices.

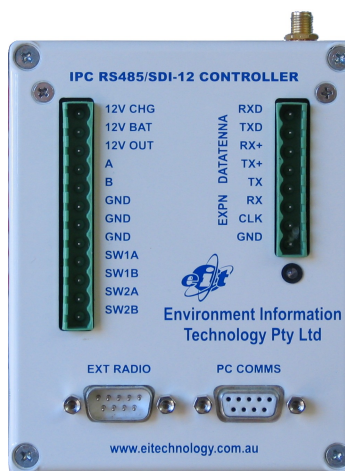
Notes These units were released in an RS485 and an SDI-12 version. They are not field configurable.
